**SITE INVESTIGATION REPORT
AND
REMEDATION PLAN
SUPERIOR CRUDE GATHERING, INC.
CRUDE OIL SPILL
INGLESIDE, TX**

July 23, 2010

PBW Project No. 3190

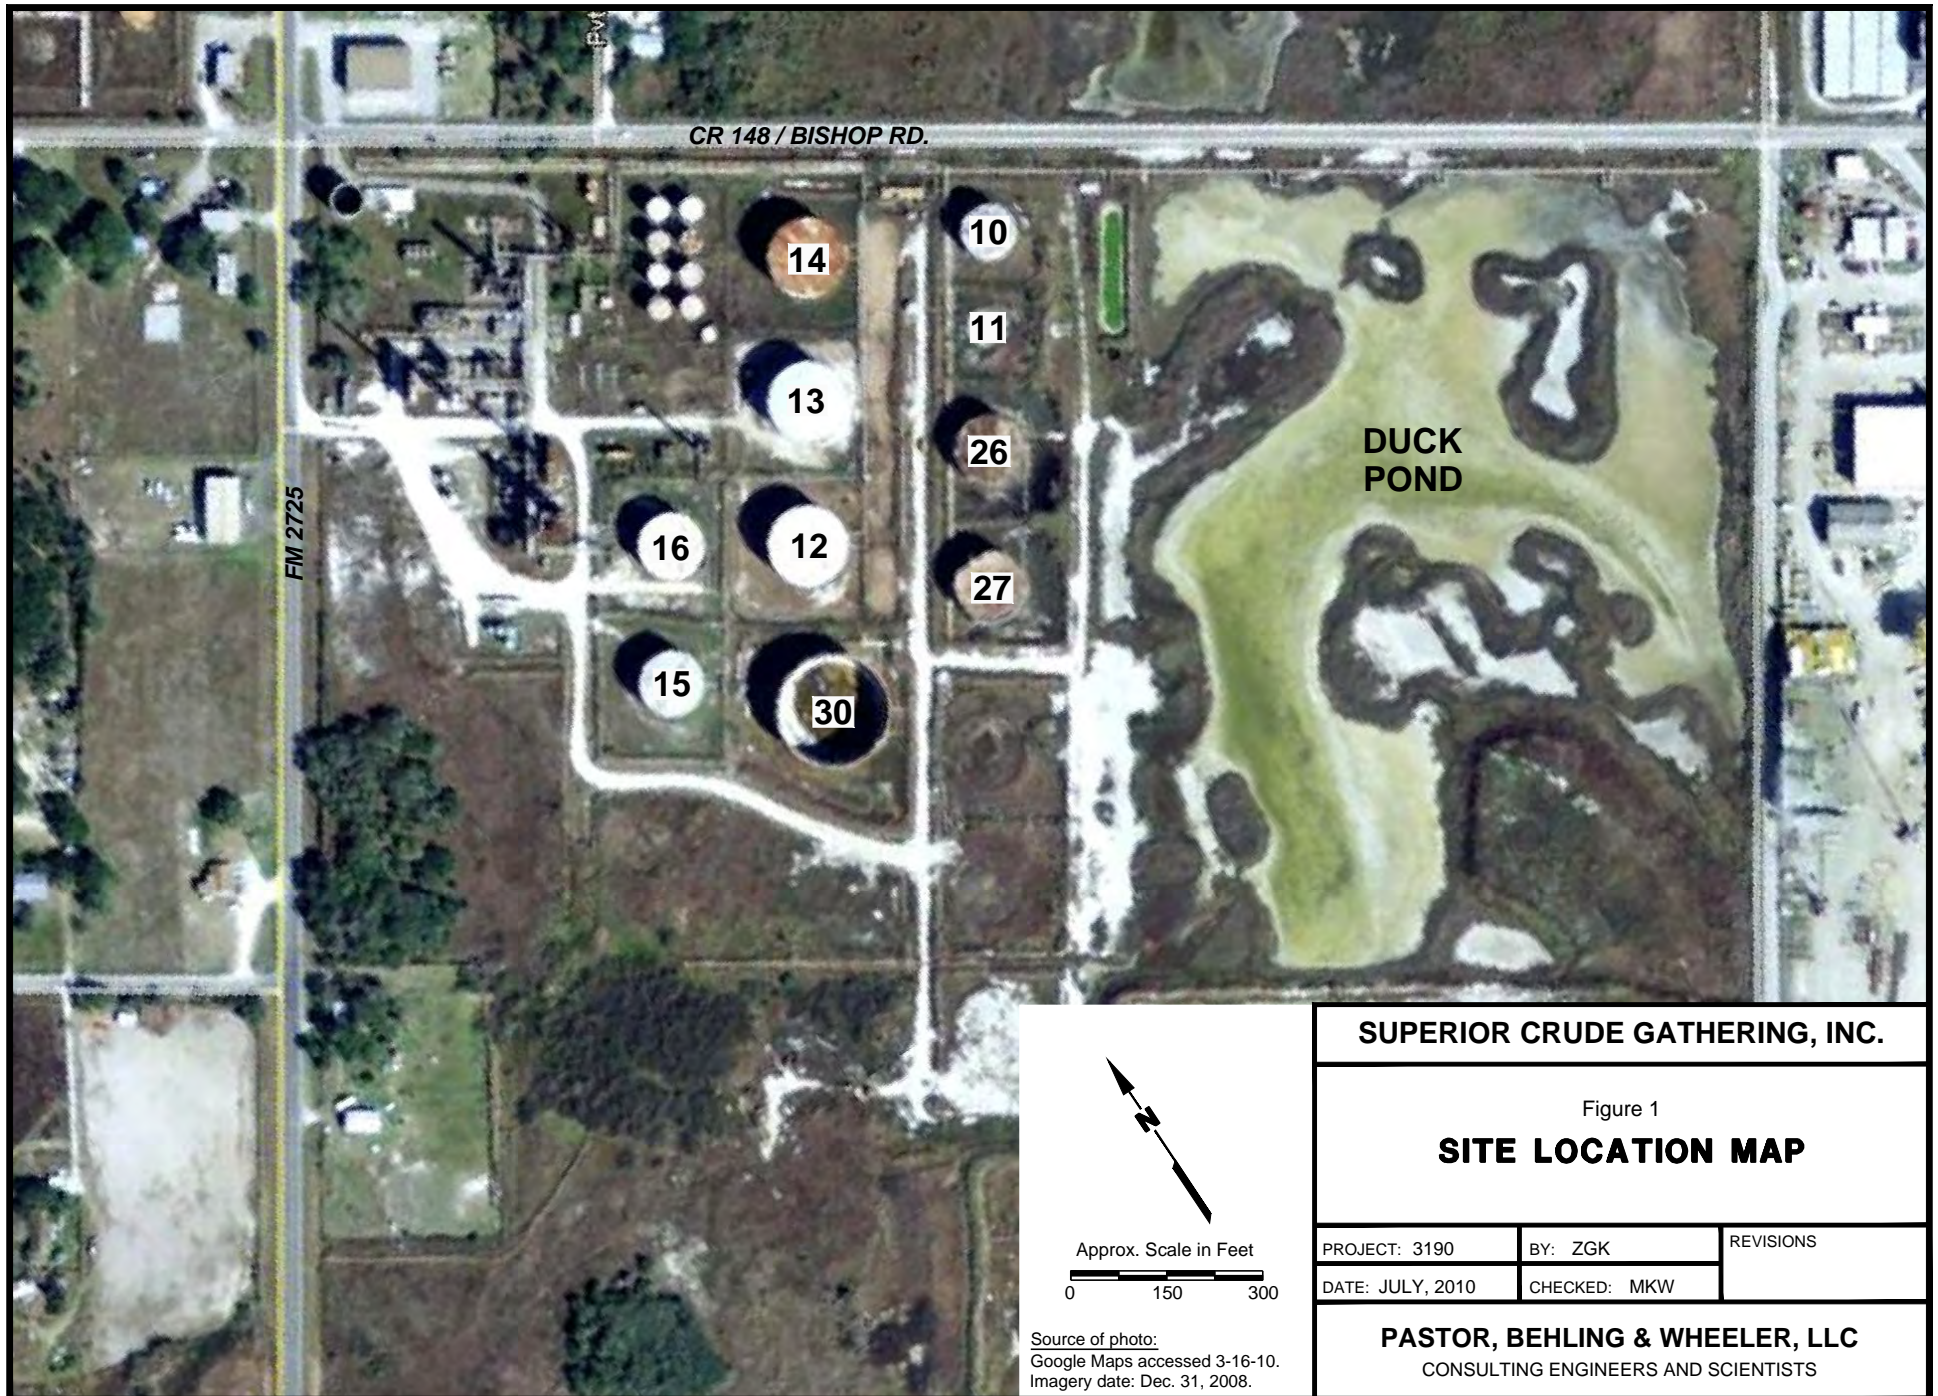
Figure 1

The Site is located within the former Falcon Refinery at 1472 FM 2725 in Ingleside, San Patricio County, Texas. The property is owned by National Oil Recovery Corporation (NORCO). Since 2002, Superior has leased three tanks (designated as Tanks 13, 15 and 16 (Figure 1)), which have a capacity of 100,000, 55,000 and 55,000 barrels (bbls), respectively. The three tanks are located within a large tank farm, as shown on Figure 1.

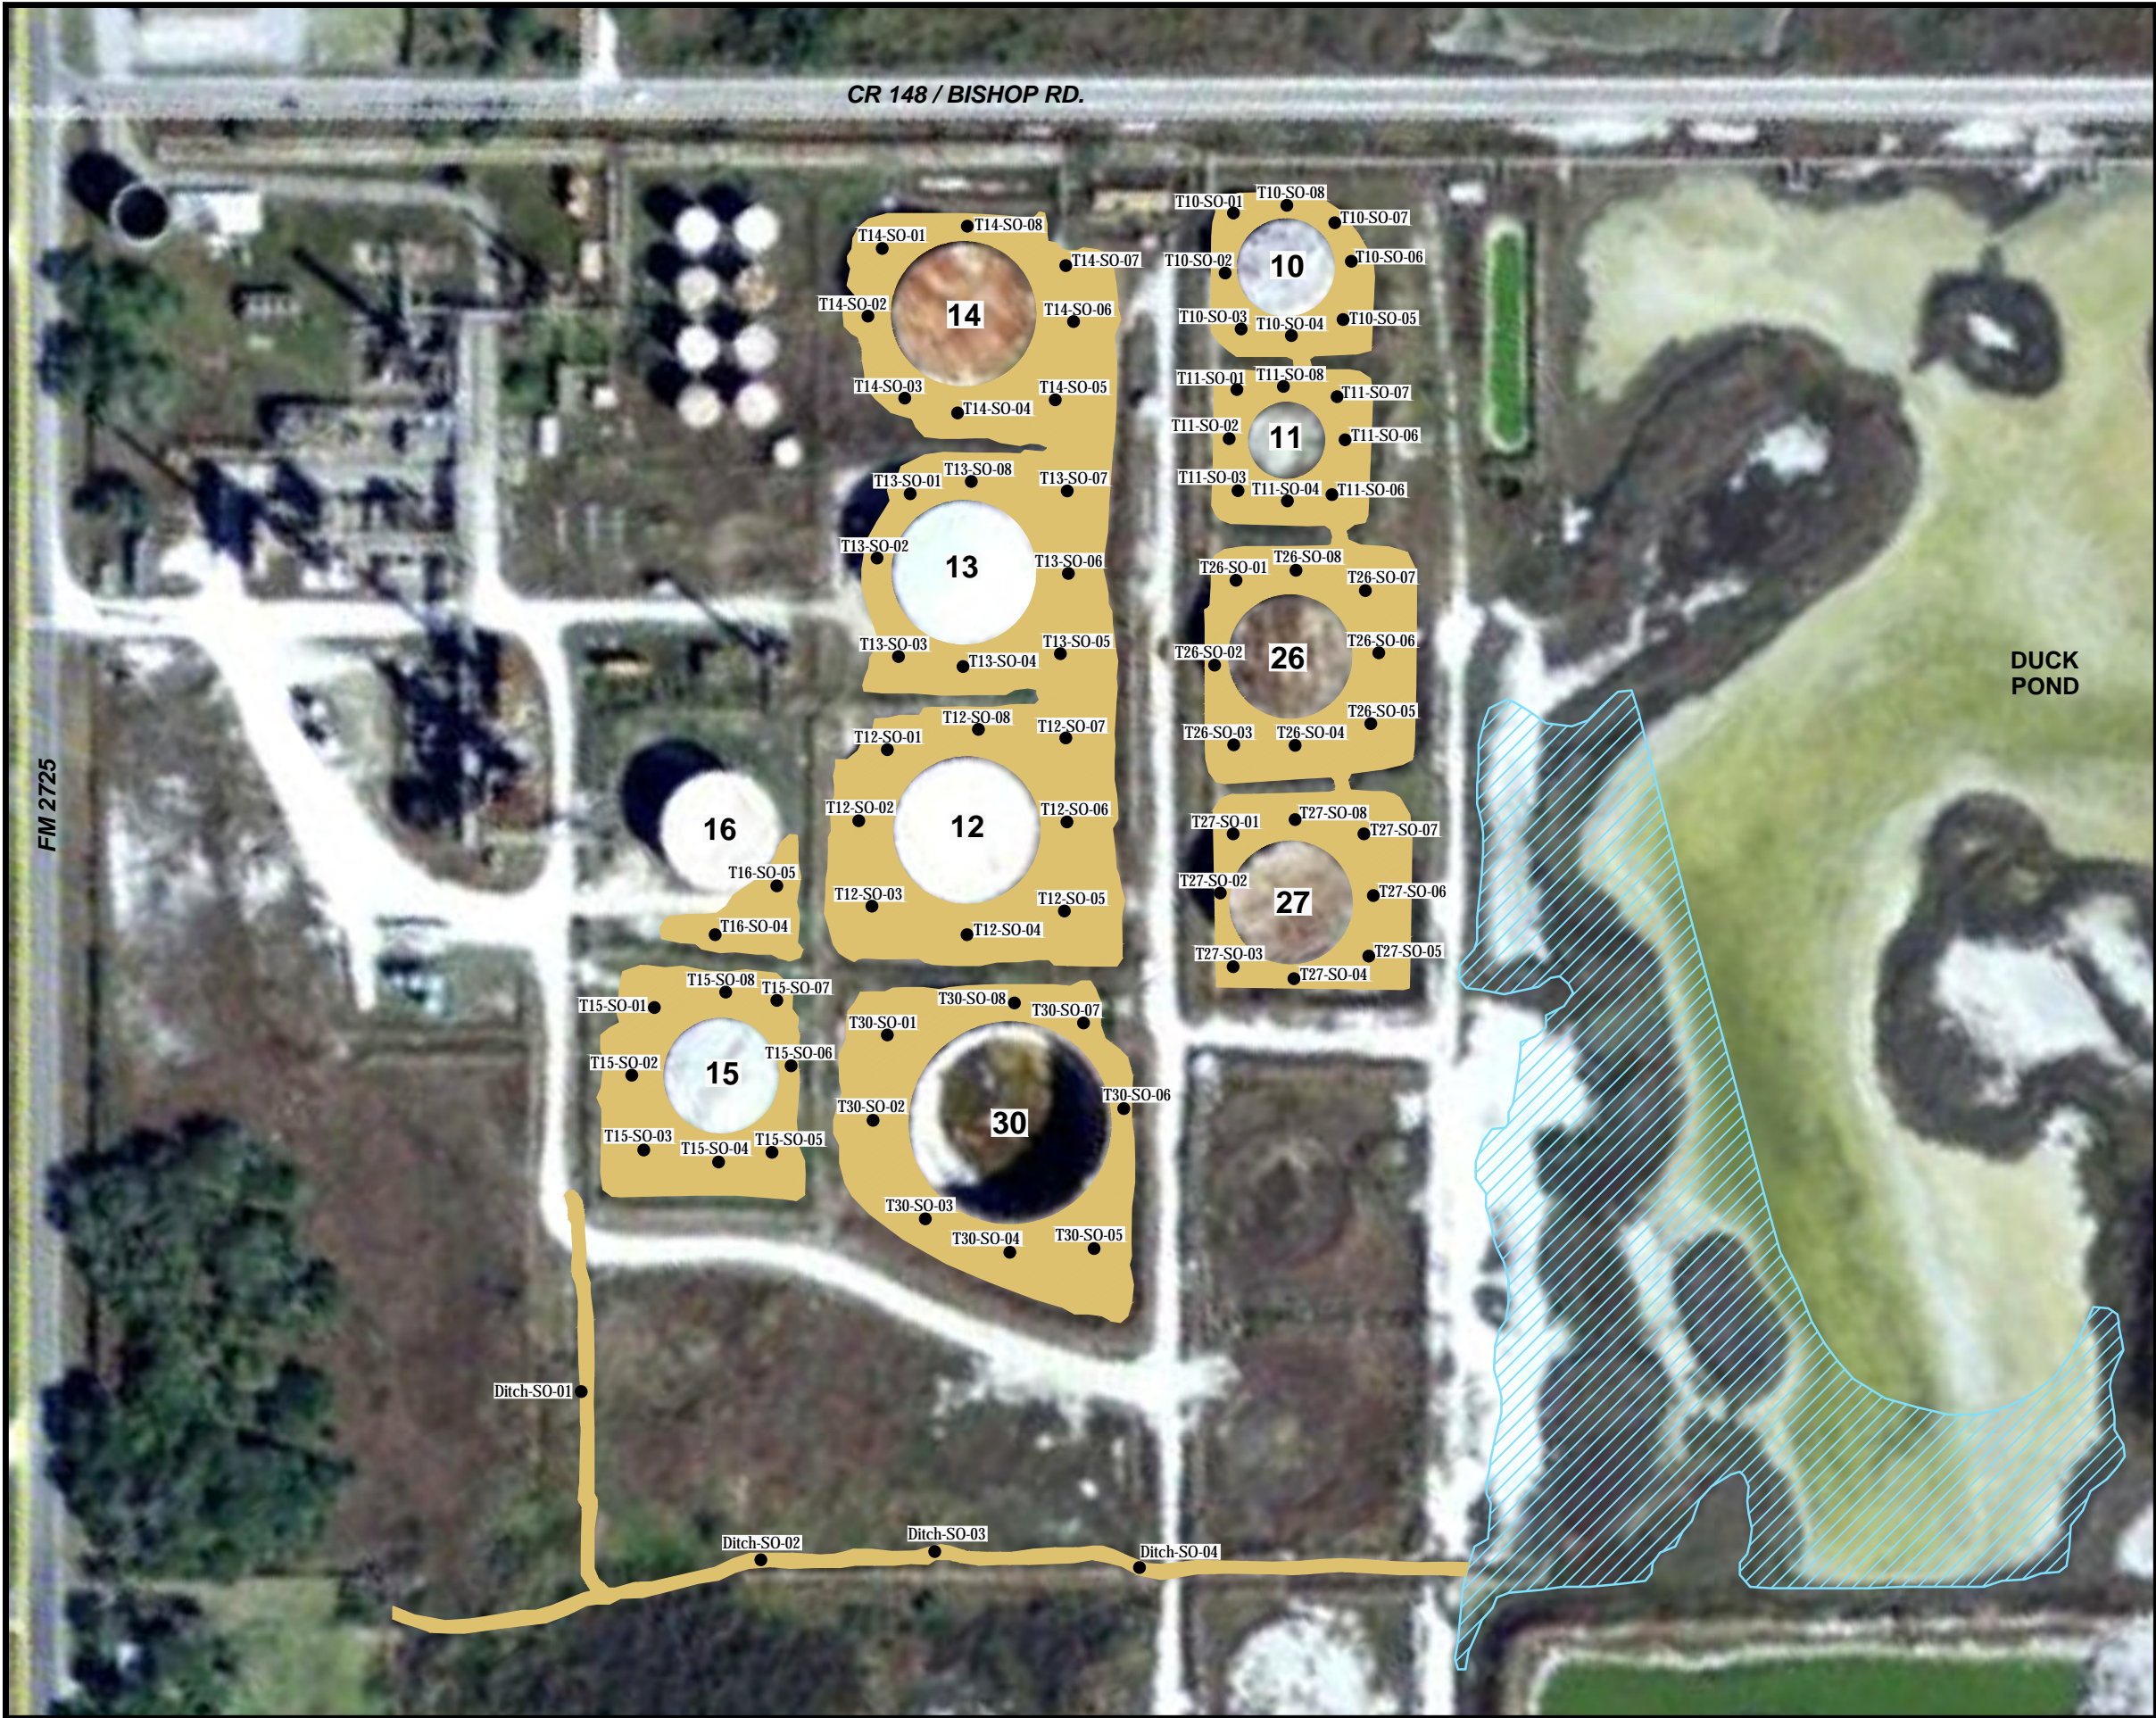
Soil samples were collected in May and June, 2010 from the locations shown on Figure 3. Soil samples were collected at eight locations within each tank containment area where crude was released. At Tank 16, because crude oil did not impact the entire tank containment area, only two locations were sampled. A total of 84 samples were collected from the tank containment areas. In addition, four soil samples were collected from the drainage ditches south of the tank farm where some crude oil flowed after the spill.

Soil samples were collected from the locations shown on Figure 3 and analyzed for TPH and BTEX. The results of the soil sampling are shown on Tables 1 and 2 (with complete laboratory analytical reports provided in Appendix C). A review of the results indicates the following:

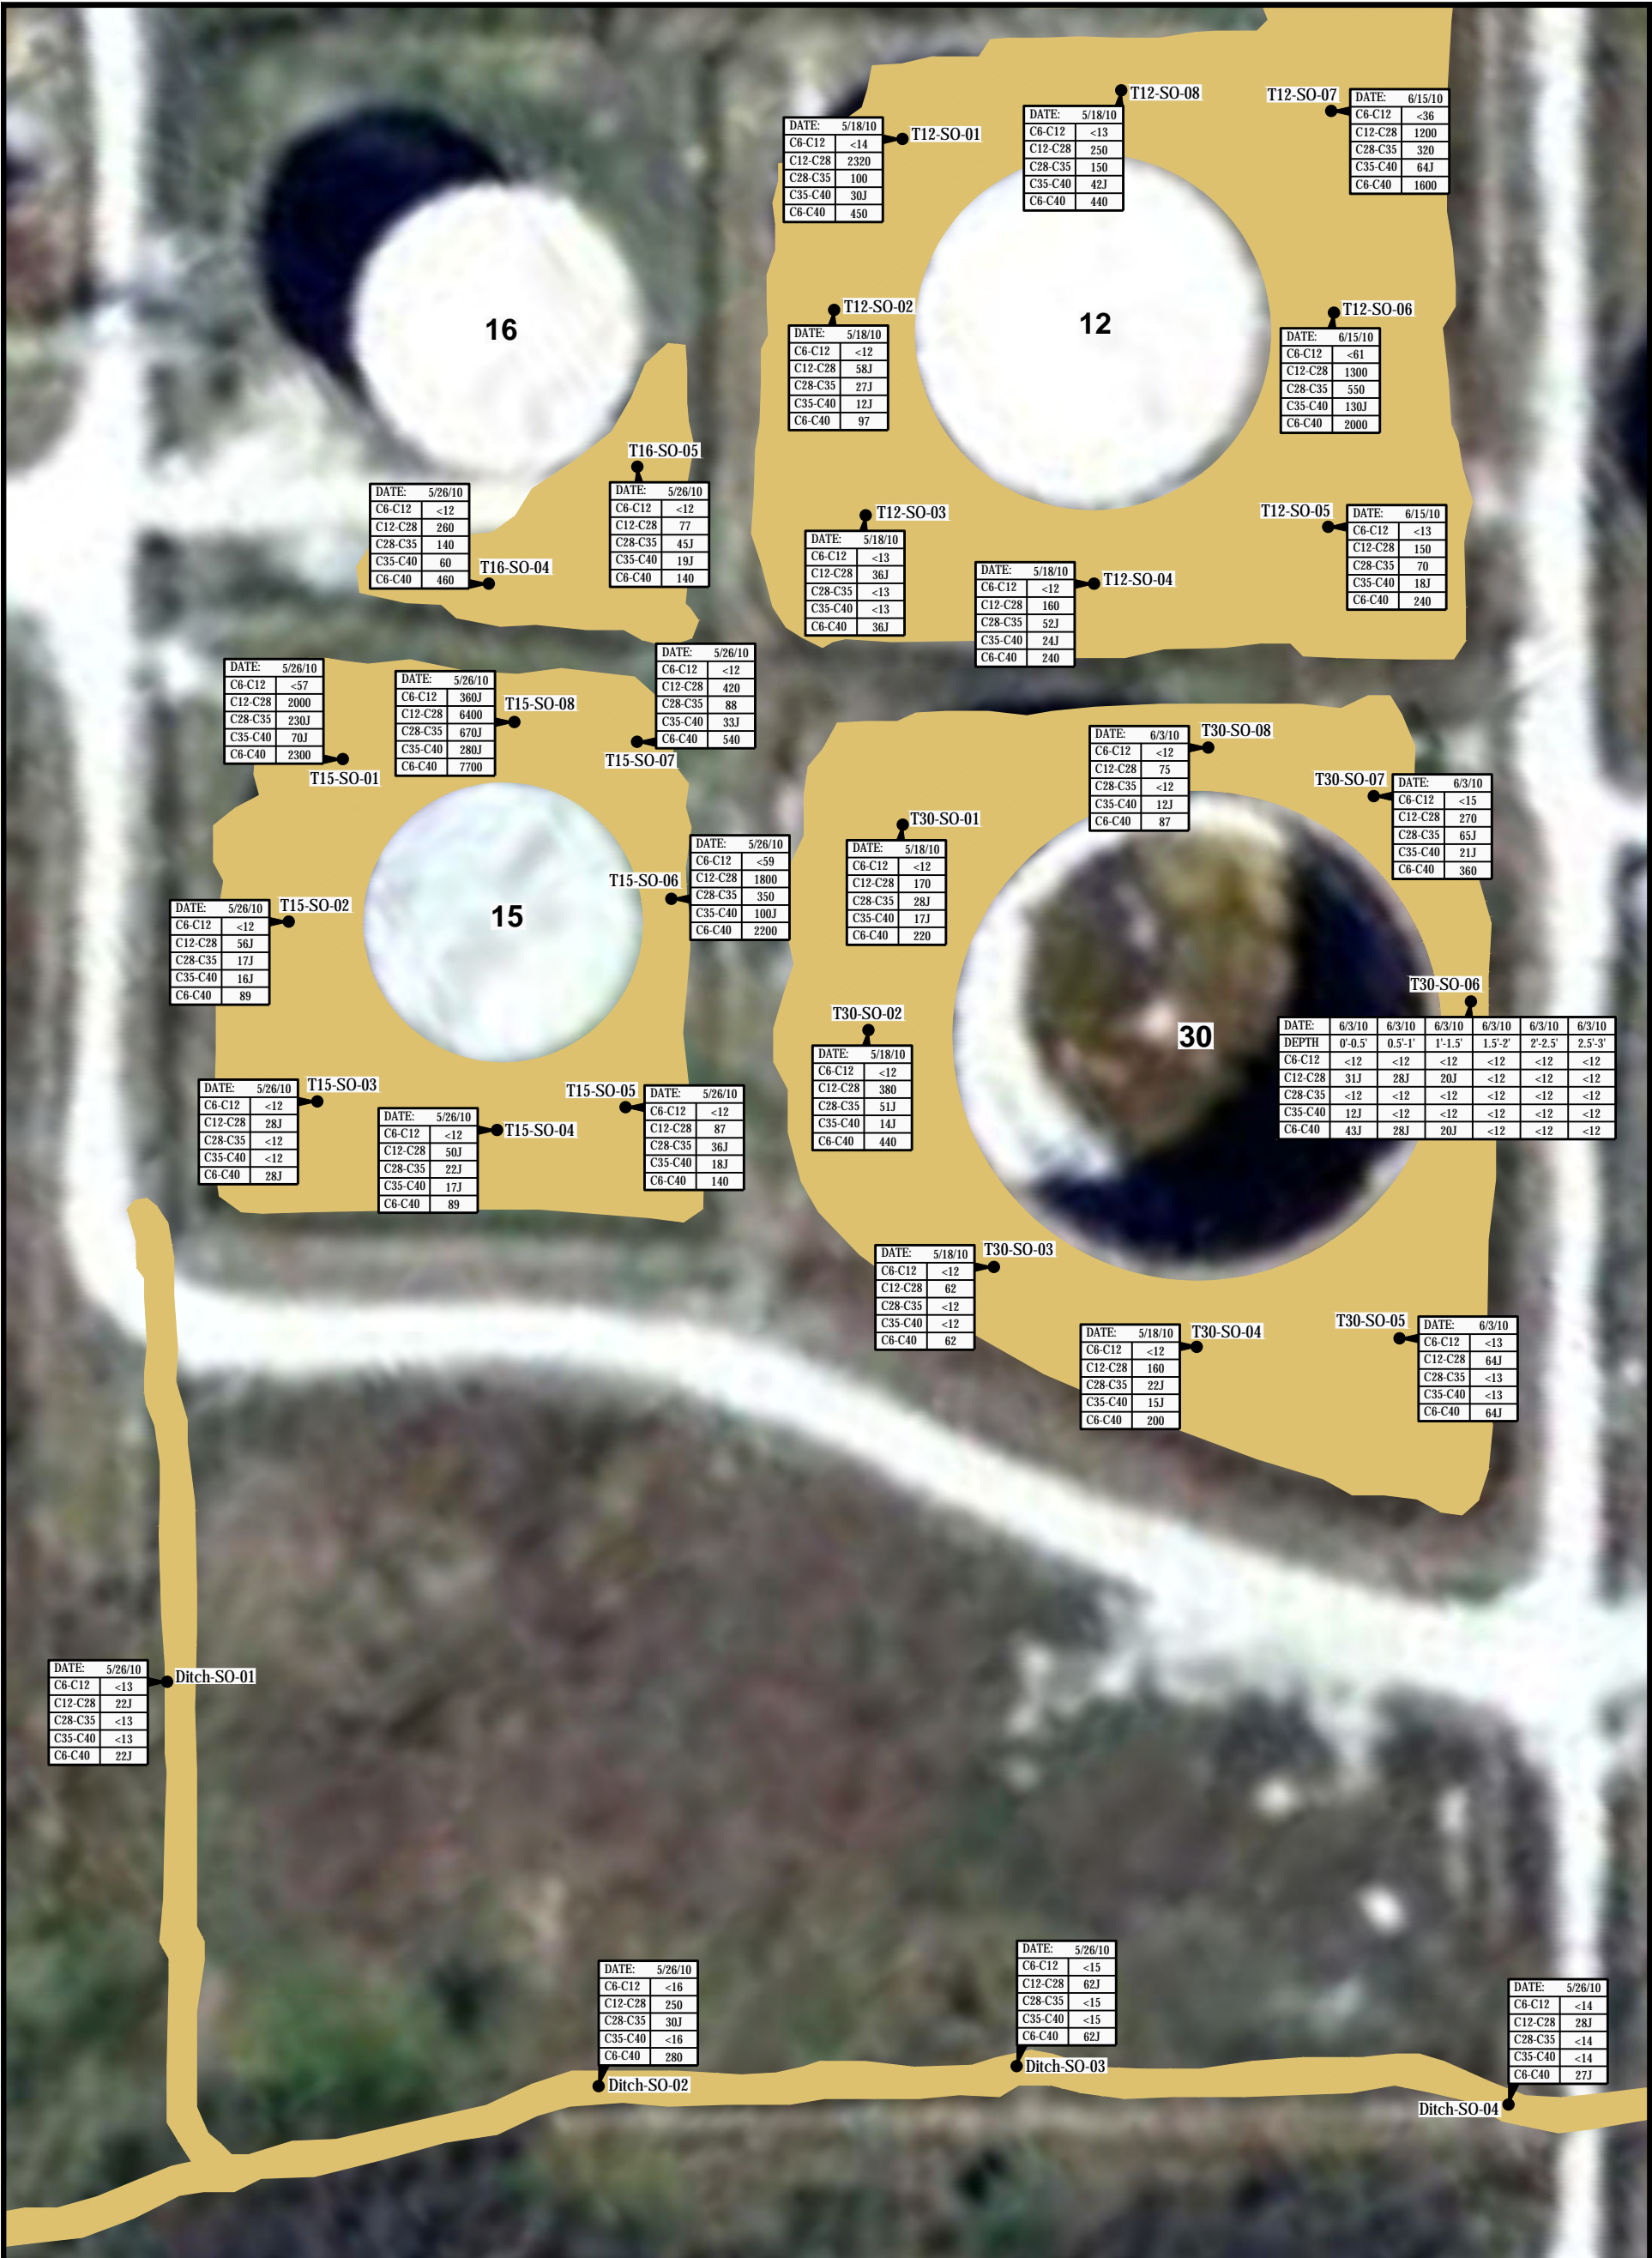
Figure 4B
TPH CONCENTRATIONS
IN SOILS

- 1) TPH TX1005 concentrations in soil samples at the site range from below detection limits to a maximum concentration of C6-C40 of 9,600 mg/kg (T26-SO-05) (Table 1, Figures 4A and 4B). Most TPH detections in soil fall in the C12-C28 and C28-C35 hydrocarbon range, as expected for a crude oil spill. Three soil samples have total TPH concentrations that exceed the critical PCL for TPH: T13-SO-05, T15-SO-08, and T26-SO-05 with concentrations of 6,900 mg/kg, 7,700 mg/kg, and 9,600 mg/kg, respectively (Table 1).

- 1) Soil will be removed from the four areas where TPH or benzene exceeded the cleanup level in soil. These areas include:
 - a. The area near soil sample T13-SO-05 in the containment area of Tank 13;
 - b. The area near soil sample T15-SO-08 in the containment area of Tank 15;
 - c. The area near soil sample T26-SO-05 in the containment area of Tank 26;
 - d. The area near soil sample T30-SO-01 in the containment area of Tank 30.
